High Resolution Computed Tomography Inspection of Components Uncovers Root Causes of Vexing Failure Mysteries

Michael R. Johnson*

Insight Instrument Deployment Arm (IDA) Motor Winding Anomaly

10 mm Motor/Gearbox Life-Test-to-Failure Determination of Failure Source

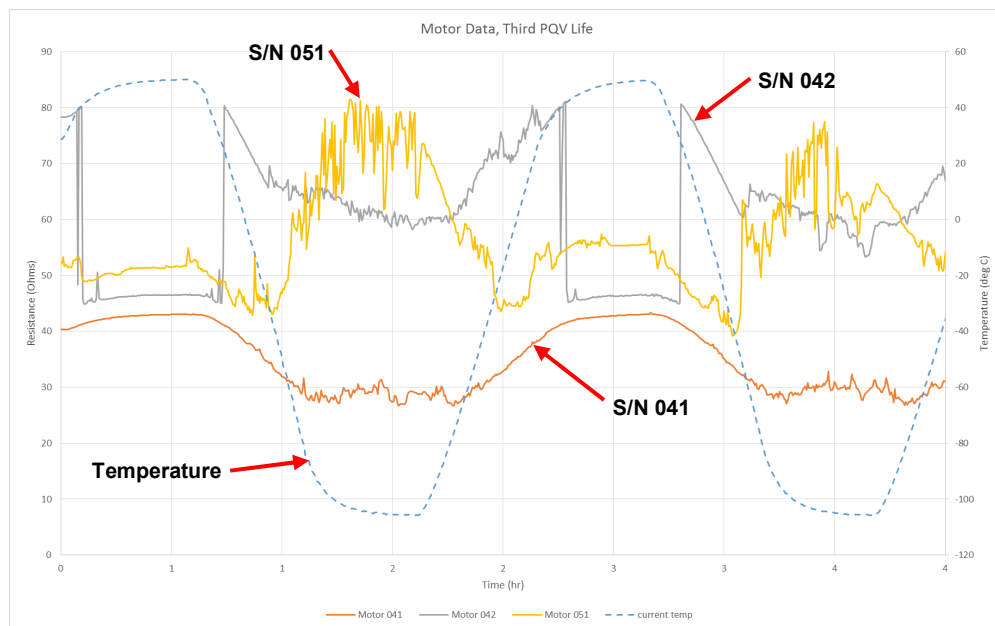
The resistance recorded for one of the three motors looked mostly as expected for the first few thermal cycles of the testing. Some measurement noise was present in the data traces. Two of the motors, however, did not produce the results expected. The traces instead appeared as in Figure 7. The blue curve is the temperature and the grey, orange, and yellow curves are the motor winding resistances.

Figure 7. Motor Resistance and Temperature versus Time Plot for Cycle #3

The orange curve is motor serial number 041, the grey curve is motor serial number 042, and the yellow curve is motor serial number 051. The winding resistance of all of the motors shows electrical noise during the region of low temperature dwells. The orange motor data performed as expected. The noise within the data was unexpected and a little troubling, but the most significant feature of the grey and yellow curves is the sudden change in apparent resistance of the windings during the transitions to and from the cold temperatures. During the cold transition, the winding resistance should smoothly lower and at no time should it indicate an increase or sudden jump up in resistance. After 38 temperature cycles, serial number 041 adopted the same signature as the other two motors, with a sudden increase of winding resistance as the temperature was lowered through the cold portion of the cycle (see Figure 8).

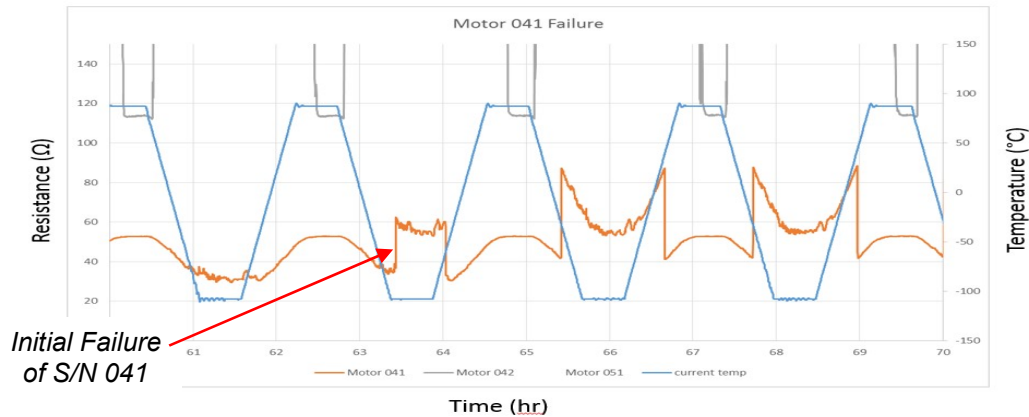
Figure 8. Failure of Serial Number 041 at Temperature Cycle #38

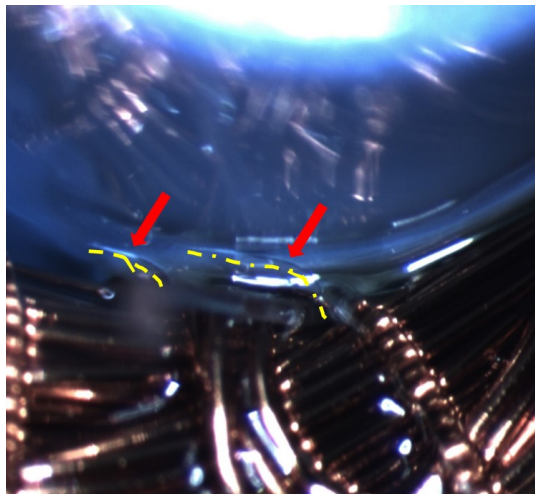
To determine the source of the strange increases in resistance, the motor was disassembled and inspected at high magnification. The motor windings are bonded together and to the rotor core laminations with an epoxy. During visual inspection under high magnification, some indications of cracks in the epoxy were detected. The images do not indicate if the cracks are the source of the winding resistance anomalies, but they are certainly potential locations for trouble. Some of the images taken are shown in Figures 9 and 10. The cracks indicated in the images were not present in the motor winding epoxy prior to the thermal cycle testing.

Figure 9. Winding/Rotor Epoxy Cracks Indicated by Lines and Arrows

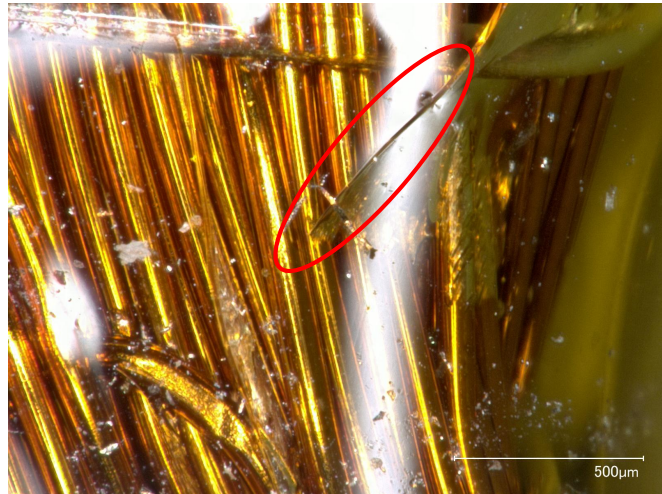
Figure 10. Winding/Rotor Epoxy - Crack in Epoxy Shown in Red Oval

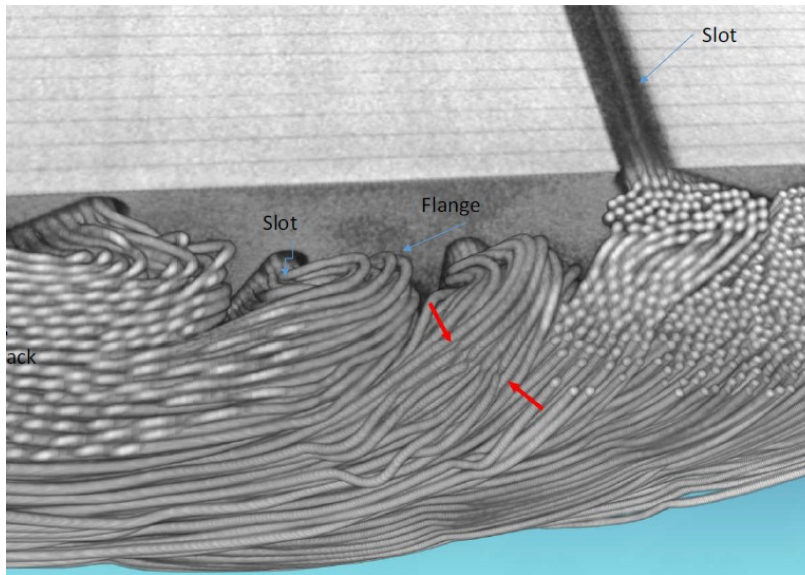
Close inspection of the CT Scan model revealed the source of the winding failures to be coincident with the crack sites of the epoxy located on the opposite end of the rotor from the commutator assembly and winding wire terminations. Figure 15 shows a close-up view of the end of the rotor where the wires exit the slots and there is indication of damage to the winding wires, identified by the red arrows. Focusing on the areas of apparent damage, the culprit is finally found to be broken winding wires at the exact locations of the epoxy cracks. The wire can be seen to have necked down prior to failing, indicating a tensile failure.

Figure 15. Magnified View of the CT Scan Model Showing the End Turns and the Slots in the Rotor Laminations

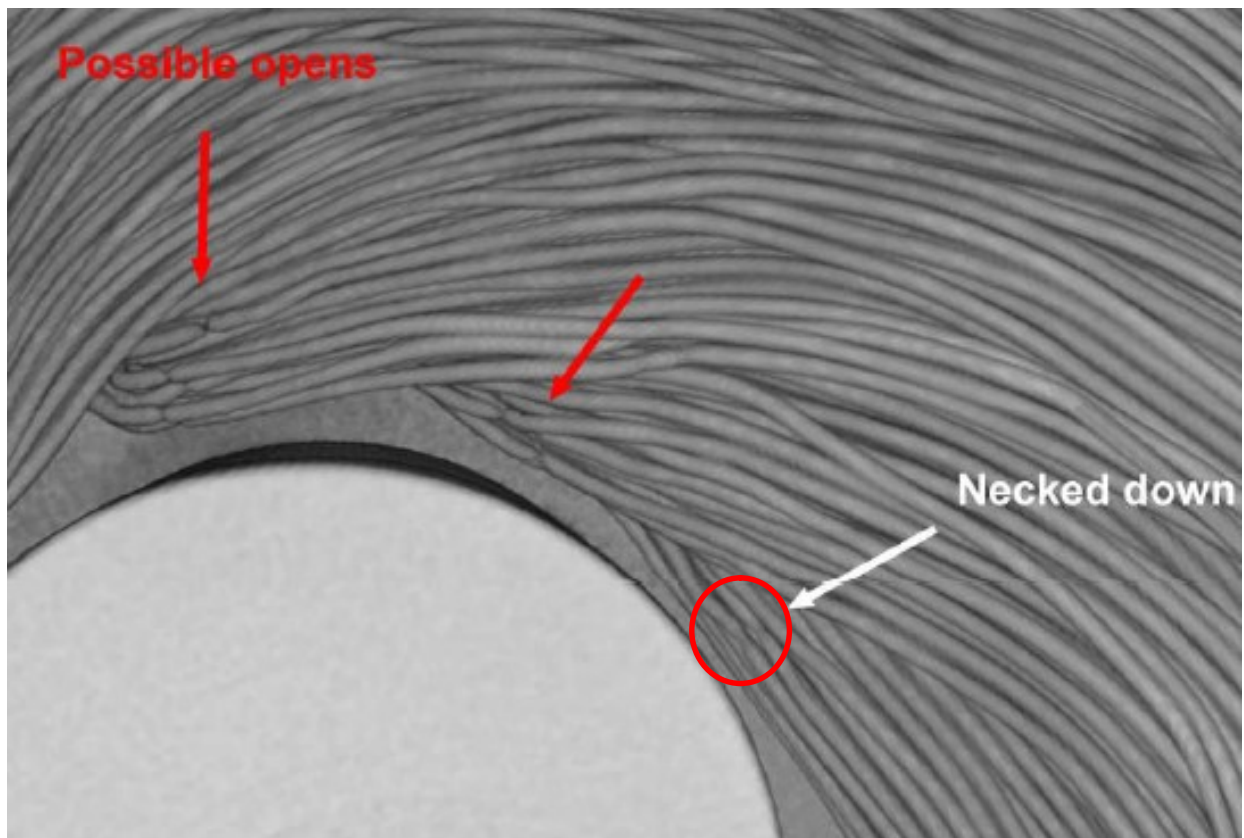
Further investigation of other epoxy crack locations revealed several failed wires and many stretched wires with necked down cross-sections. The necking would account for resistance changes in the first few cycles after the epoxy crack propagated to the location of the wires. The sudden increases of winding resistance in the test data were the result of several broken regions moving back together as the temperature was raised. While the winding resistance might have appeared nominal at a higher temperature, the winding wire damage points would certainly not have supported a high enough load current to produce the required torque output from the motor in the IDA application.

Figure 16. View Showing Several Locations of Failed Wires. The Necking Down of the Breaks Indicates Tensile Failures. The Wire Breaks Follow the Cracks in the Epoxy Coating. The wire diameter in the image is 80 microns.

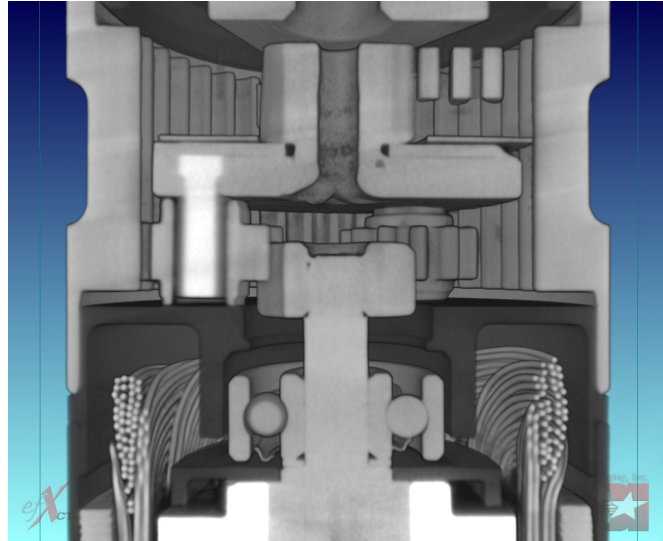
The view of the first stage of the planetary gears seemed to show an offset of the pinion gear toward the motor. This necessitated an inspection of the front motor bearing. Looking at a section of the model from the side in Figure 24 shows that the motor bearing appears to have shifted downward in the image and the motor pinion gear has done the same. Scrutinizing the bearing assembly itself shows no unusual wear or debris. All other elements of the motor assembly in this region seem fine.

Figure 24. Side View of the First Planetary Gear Stage with the Motor Pinion at the Center. The Bearing is Displaced Downward in the Image

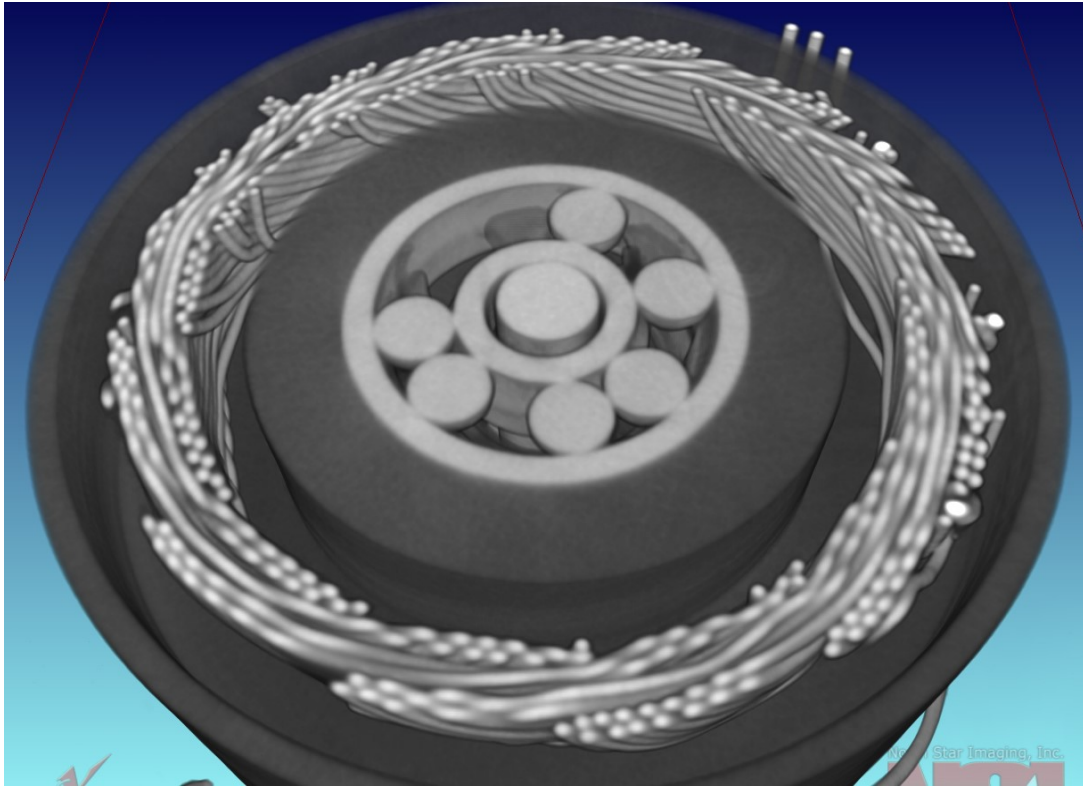
Inspecting the CT Scan model further finally showed a source of the drag. The rear motor bearing is shown in Figure 27 and the ball separator is missing. The balls have moved within the bearing assembly to a position where they have jammed and the bearing will not rotate. While the jammed bearing appeared to be the guilty party, it could not explain an increasing torque load over time. The problem with the bearing jam being the source of the drag is the jam does not allow the bearing to rotate. This should have stopped the actuator suddenly and not in the manner of a slowly increasing drag torque.

Closer inspection provided the needed clues to the solution. The shaft in the bore of the bearing in figure 27 appears to be smaller than the bore. Figures 28 and 29 show a side-by-side comparison of the end of the motor with an as-built beginning of life motor on the left and the failed life test motor on the right.

Figure 27. View of the Rear Motor Bearing Showing the Balls Have Displaced Around the Circumference of the Bearing Races to a Jamming Position. This Makes the Bearing Unable to Rotate at All.

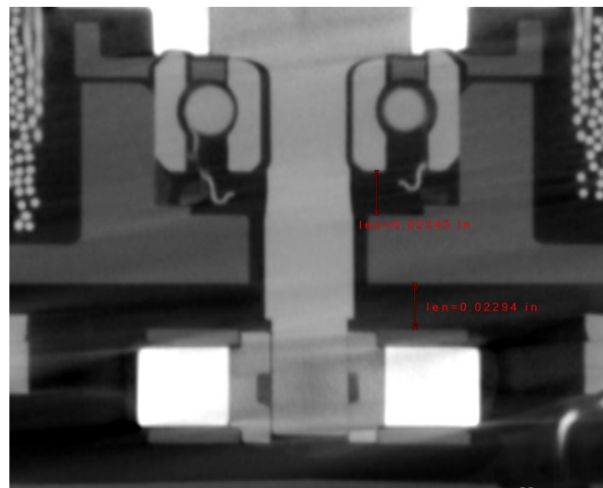
Figure 29. Life Test Motor Showing Shaft Wear and the Bearing Having Moved Toward the Rotor. The Ball Retainer is Seen Located Under the Bearing Assembly. (0.0229 in = 582 microns)

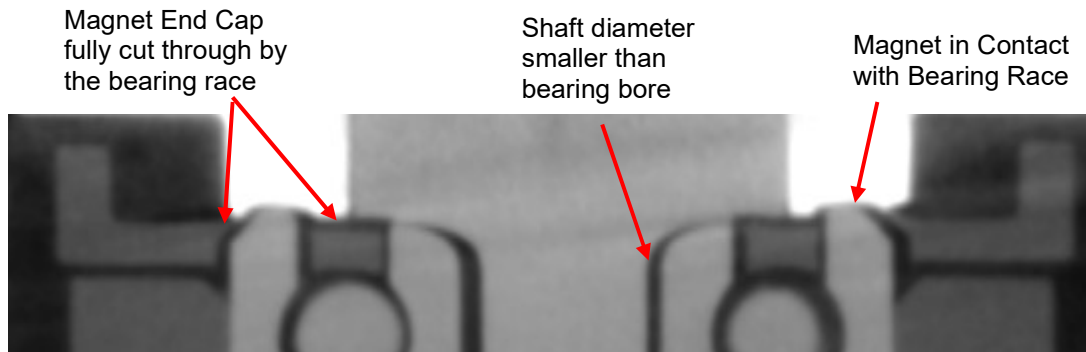
Figure 30 shows a close-up of the rear ball bearing and where it is dragging on the rotor (from Figure 29). The bearing has cut through the magnet end cap (aluminum) and started cutting into the magnet material. The rotor diameter has also worn significantly smaller than the bearing bore. The root cause of the failure

was the bearing seizing and stopping rotation. This was followed by the rotor shaft rotating in the bore of the bearing inner race. Since a stepper motor does not provide current feedback that is related to load torque, the jamming of the ball bearing was not detected. This event was missed because the motor rotor was assembled with a small clearance to the ball bearing bore and that allowed the rotor to rotate within the bore of the bearing. This motion started the wearing of the rear section until too many components were dragging on each other.

Figure 30. Close-up of the Motor Rear Bearing Showing the Wear of the Components of the Rotor

An interesting point is the components all have a thrust load on them that draws them toward the rotor. This thrust load is from the magnet flux at the end of the magnets. This is often not a significant player in the performance of a motor, but the thrust load is enough to draw the component into the rotor such that, if there is sliding contact, significant wear can occur.

Lastly, making the rotor free to rotate within the motor bearing bores, if possible, provides a robust and graceful degradation path for actuator motors. This is especially important at the lowest torque location within the mechanism – the motor rotor.
